8.2 Barrel Region

The pixel detector barrel region (see Figure 1) has three concentric layers with modules loaded on local supports (staves) supported by three shells. The global support described in section 8.1 surrounds the shells and supports them through four radial fingers at the end of the barrel region. Each stove [1] is about 800 mm

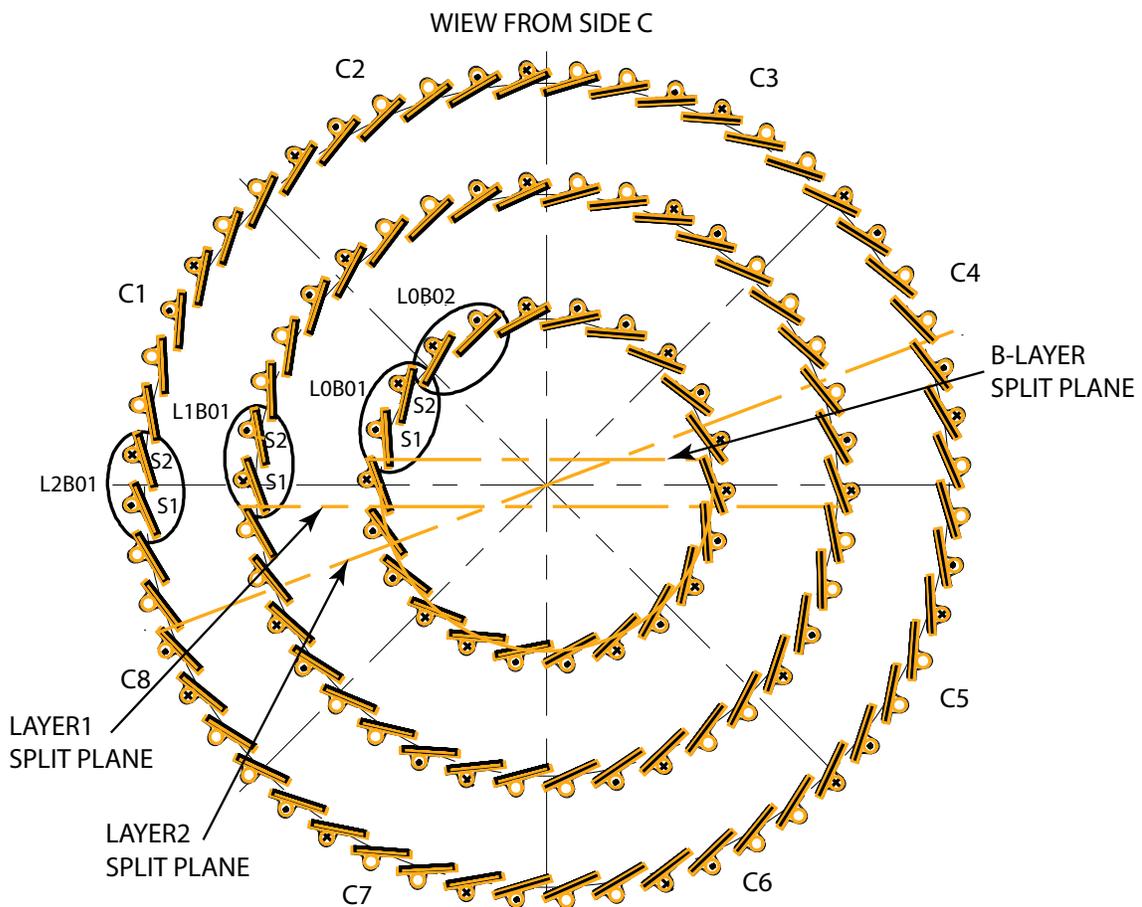
Figure 1: Layout of the Pixel barrel region. Support shells are not shown.

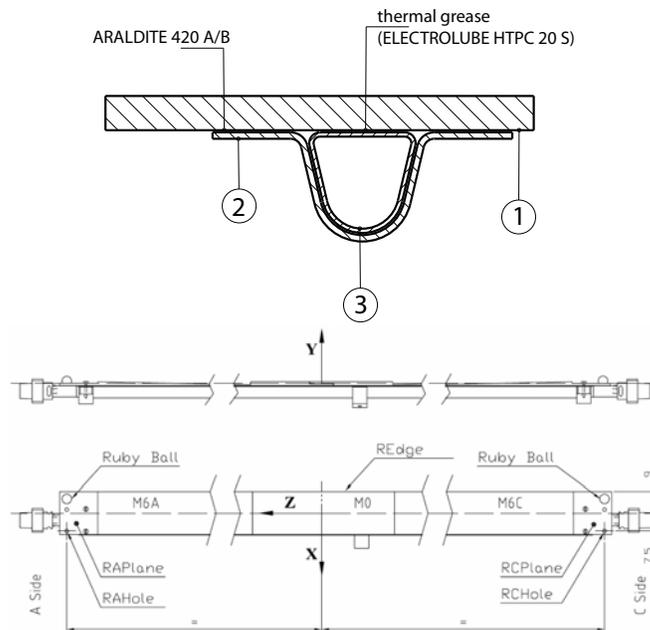
Figure 2: (a) on the left, cross section of a stave. Part 1 is the TMT, 2 is the omega piece and 3 the aluminum pipe. (b) on the right, longitudinal views of the stave with the reference system used for survey.

A stave is an assembly of three parts (see Figure 2): a Thermal Management Tile (TMT); the omega piece; and the cooling pipe. The TMT is machined out of a

A D-shaped (see part 3 in Figure 2) aluminum pipe, with 0.3 mm thick walls, is sandwiched in the TMT/Omega structure. It provides the cooling channel for the C₃F₈ coolant. The aluminium tube is made of a 6061 Al-alloy, precisely shaped by extrusion to fit inside the omega piece with a clearance of 50 μm. The tube hydraulic diameter is 4.15 mm, which allows cooling of two staves in series with an acceptable pressure drop. A pressure drop of about 50 mbar over one stave has been measured during the thermal tests. Thermal grease²⁾ is used to fill the gap between the tube and the TMT. Use of this grease interface reduces the mechanical coupling between the tube and the C-C. This minimizes the stave distortion from cool down. The main characteristic required for the thermal compounds, is a good stability under radiation, and a good thermal conductivity (>1.5 W/mK).

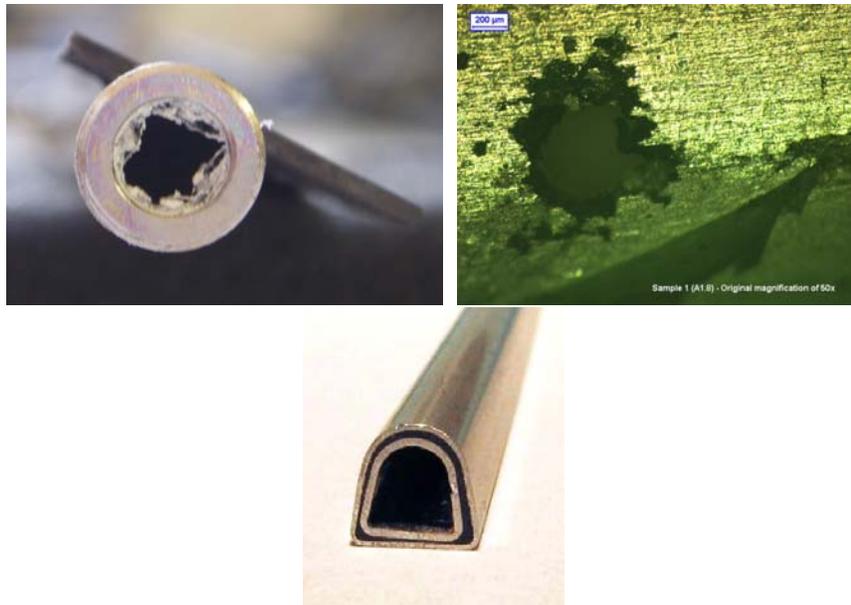
Figure 3: On the left, a view of the end of the stave pipe after corrosion. The nickel layer is detached from the aluminum by the formation of aluminum oxides. The picture in the centre shows a detail of the pipe with a through hole. On the right, a picture of an inserted pipe to recover staves already loaded with modules.

Corrosion. The original design had the aluminium pipe extremities coated with nickel, by an electroless process, in order to attach aluminium fittings by brazing. Staves, before and after modules were loaded, went through a qualification process that used an aqueous solution as a coolant. The presence of water triggered a corrosion process in the aluminium pipes. The corrosion was due to a galvanic process where water and traces of halogen (like Cl) acted as an electrolyte. The effect of the galvanic corrosion that led in some cases to holes in the pipe, as may be seen in Figure 3.

A significant number of staves had already been loaded with modules when this problem was found. The solution implemented was to insert a new pipe into the existing one. The inserted pipe (see Figure 3) has necessarily a smaller hydraulic diameter that significantly increased the pressure drop along the pipe. The evaporation temperature depends on the pressure and there is a difference in the temperature (ΔT) between the first (higher T) and last (lower T) module of a bi-stave.

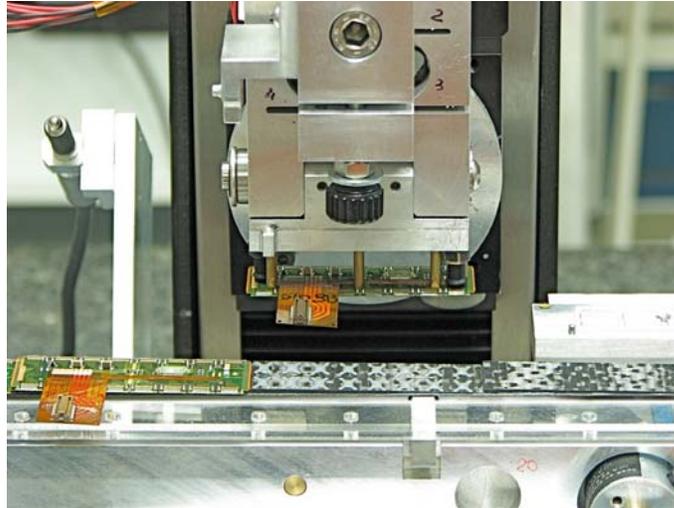
Figure 4: Loading robot used in sites 1 and 2. Blow up of the module pick-up head.

The loading procedure and the qualification tests are described in the following paragraphs. Stave loading was done on specially designed robots in a semi-automatic way by trained operators. Three module loading robots were installed: sites 1 and 2 had similar designs (shown in Figure 4), while site 3 had a different one [2]. All setups were located in clean rooms with temperature control.

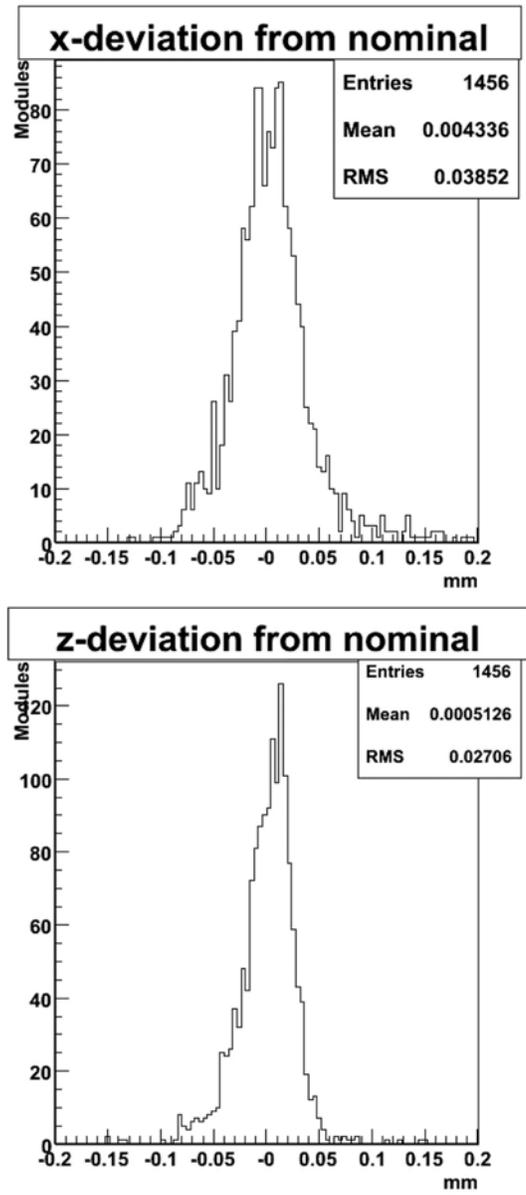
Figure 5: Deviation of module positions from nominal values for the barrel modules.

A loaded stave was surveyed on a CMM with optical probes. Deformation of pixel modules (bow) was measured using different methods. All measurements were taken with respect to the two ruby balls mounted on each stave. The deviation of modules position from nominal in X (transverse to the stave axis) and Z (along the stave axis) coordinates are shown in Figure 5 [3]. Only a few modules have deviations bigger than $50\ \mu\text{m}$.

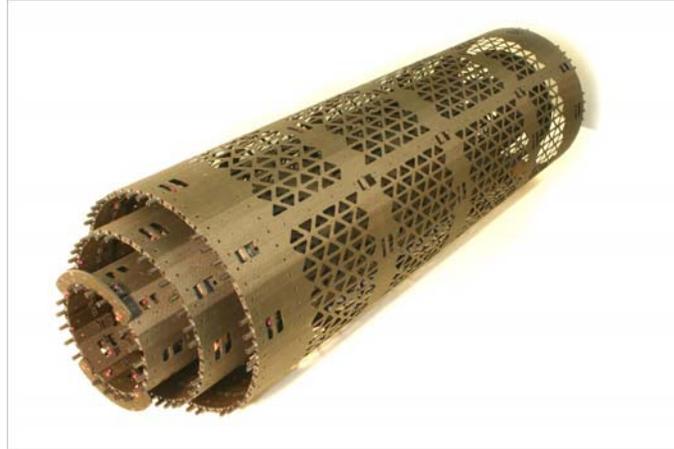
Figure 6: Picture of the three barrel shells

The barrel shells (see Figure 6) are constructed from two half-shells. Bi-staves are attached to a half-shell. Ten aluminium-alloy fasteners screw each bi-stave to the shell. All the shells are supported off the end-cones of the pixel support frame (Section 8.1) PEEK elements are bonded at both ends of the half-shell to provide the interface to the fingers of the end-cones. Shells were made from carbon-fiber-reinforced material. A quasi-isotropic laminate made of six plies ($0^\circ/60^\circ/-60^\circ$) of unidirectional ultra-high-modulus carbon fiber⁶⁾/cyanate-ester⁷⁾ prepreg was made. The shells are not cylinders, but have flat surfaces locally. The overall mass was reduced by cutting out material in each shell, as show in Figure 6.

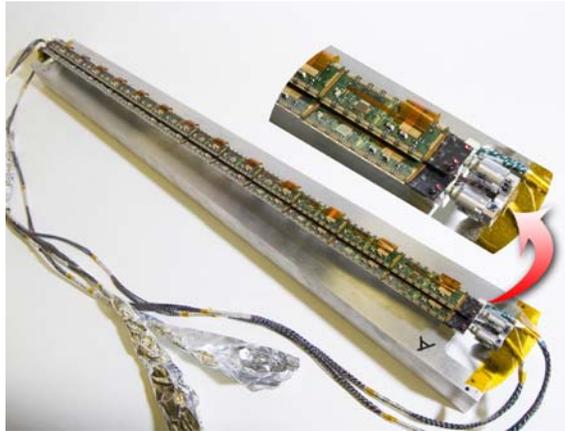
Figure 7: A bi-stave assembly.

Two staves (see Figure 7), each loaded with 13 pixel modules, were assembled together. Type 0 cables (section 8.5) were connected to the module and properly routed along the staves. Electrical testing was done during bi-stave assembly as was leak checking of the two cooling loops.

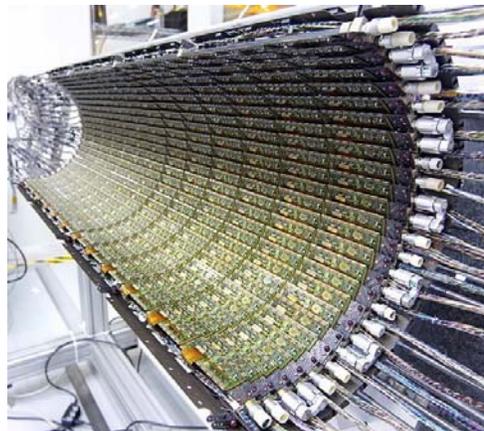
Figure 8: Layer 2 half-shells with all the bi-staves installed.

Bi-staves were integrated by hand into the half-shells starting with Layer 2 and proceeding to the B-Layer. Figure 8 shows one of two half-shells with all the bi-staves installed for Layer 2.

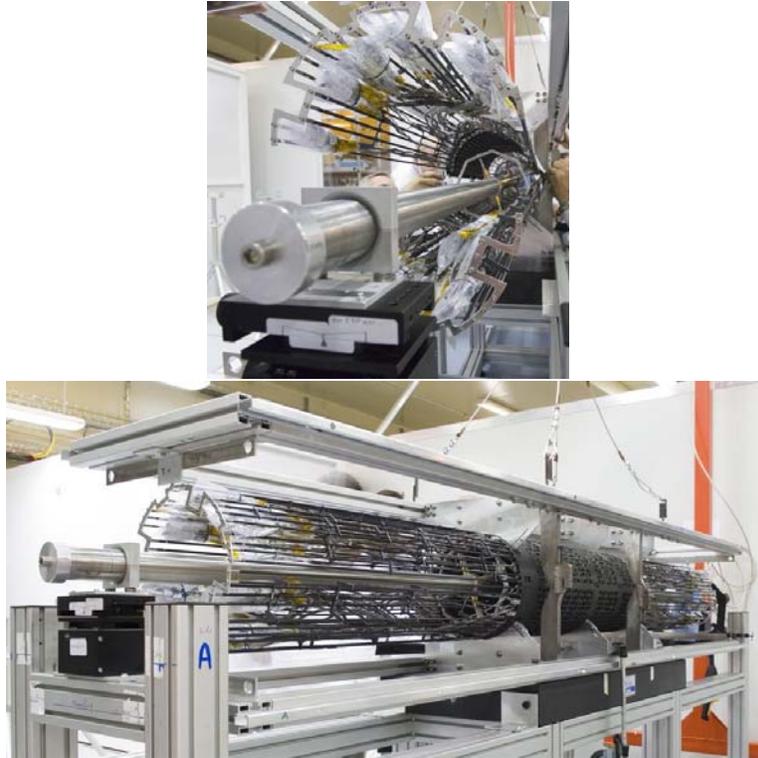
Figure 9: Clamping of the Layer 2 half-shells. The top half is craned onto the bottom one resting on the STT (see text). The picture shows the mechanism that guides the process. The stainless steel pipe, visible along the the axis of the shell, was used to guide the insertion into the global frame and was removed afterward.

Two half-shells of each layer were clamped together into a complete shell. A half-shell lacks torsional stiffness (around the axis of cylinder). Half-shells were stiffened with an external structure and kept undeformed during the integration process. The Shell Transferring Tool (STT) held each of the two half-shells by ten clamps that grabbed each half-ring in two places. The tool was placed on the flat surface of a granite table that provided the reference plane. The bottom half-shell is kept on the STT and the top one was lowered until it engaged the clamping features (see Figure 9).

The operation was delicate due to the fact that the wire bonds of the modules were exposed and clearances were about 1mm. Once the half-shells are joined, they can be removed from the STT. The load of the shell was taken by the metal pipe passing through the shell and visible in Figure 9. Figure 10 shows the Layer 2 Shell clamped and moved onto the Integration and Testing Tool (ITT) for integration into the global support frame (Section 8.6). The Layer 1 followed the same clamping procedure. The B-layer required a more complex procedure. The flanges at the extremities of the beam pipe do not pass through the B-Layer and it has to be clamped around them (Section 8.6). More details of the assembly and testing procedures can be found in [4].

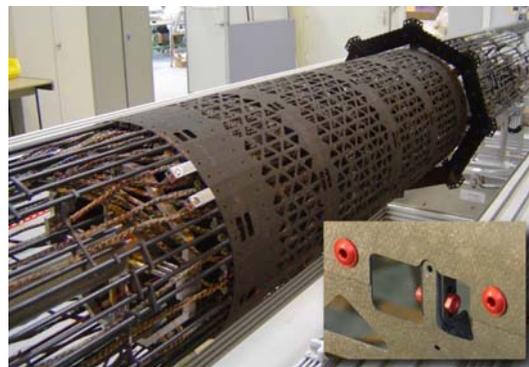
Figure 10: Layer 2 clamped and resting on the axis of the ITT before being inserted into the global frame.
